Surface Water Assessment

Report

Surface Water Baseline Conditions

Prepared for Tellus Holdings Ltd

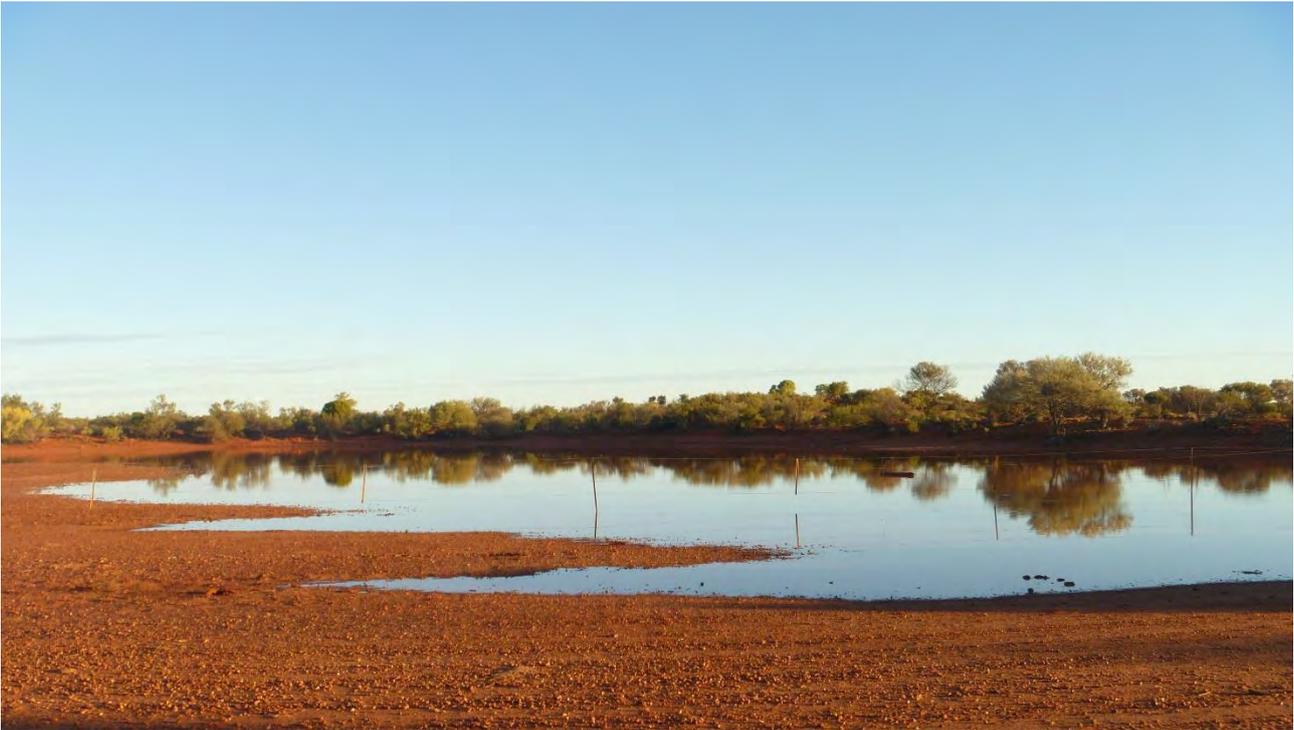
Figure 22 Example clay-pan feature approximately 3km east from rail line crossing
